# Manhole Inspection Summary

Manhole # S43I\_\_043MH

Insp Date: **4/29/08 3:20 PM**

**Location** Address: **1719 eastern ave**

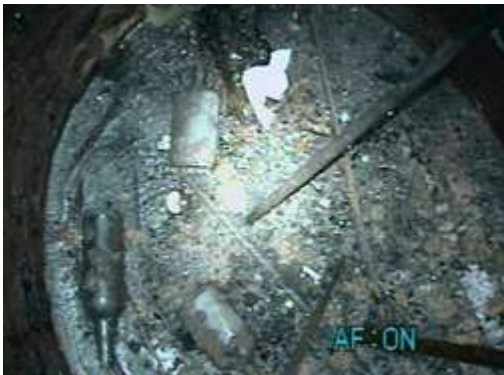
Defect 4

Condition: ☐ Sound ☐ Cracked ☐ Root Intrusion ☐ Deteriorated ☐ Leaks ☒ **Debris**

channel debris

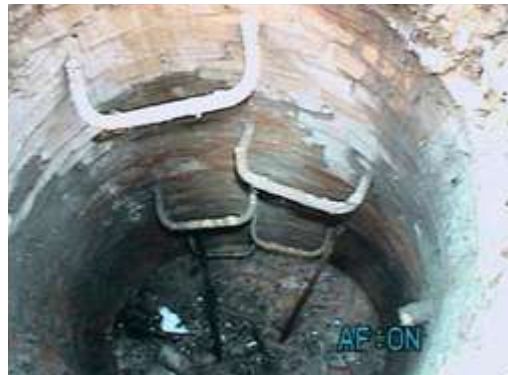
Defect 3

Infiltration: ☐ None ☐ Joint ☐ Cracks ☐ Mortar ☐ Roots ☒ **Wall**

Count: **5** Missing: **0** ☒ **Corroded**

infiltration from barrel wall, corroded stairs

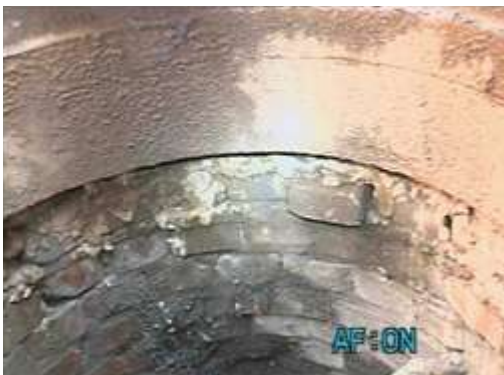
Defect 2

Condition: ☐ Sound ☐ Cracked ☐ Root Intrusion ☒ **Loose Brick** ☒ **Deteriorated**

chimney loose bricks, deteriorated

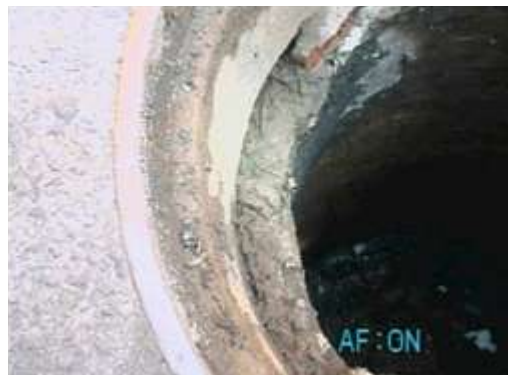
Defect 1

Offset: **2.5** (in.)

off set frame

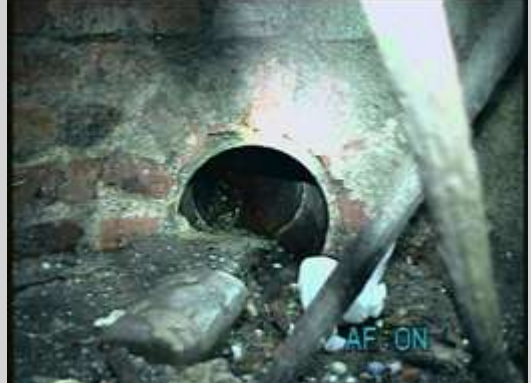
12 O'Clock Outflow

Deposits: ☐ None ☐ Mud ☐ Sludge ☒ **Debris** ☐ Grease

Silt Depth: **2** (in.) Deposits Extent: **Light**
